Technical Report

CATHODIC PROTECTION SYSTEM

FOR FLEET MOORINGS

Technical Report R-702

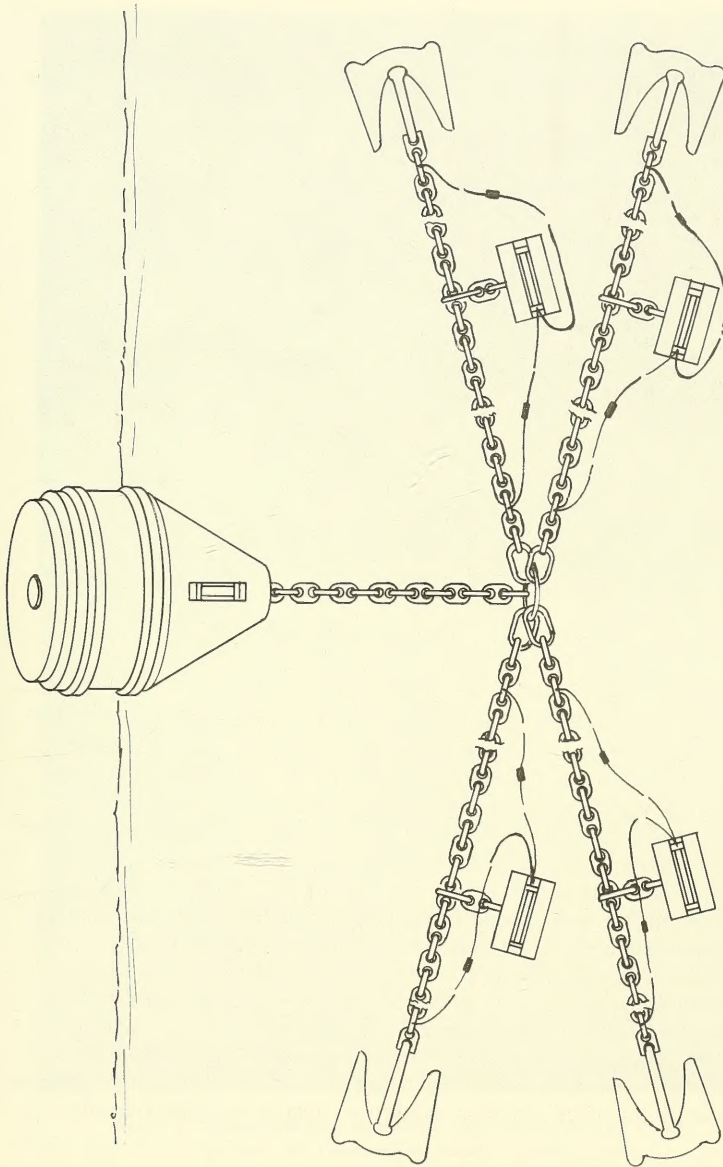
Figure 1. Design of initial cathodic protection system utilizing magnesium anodes.

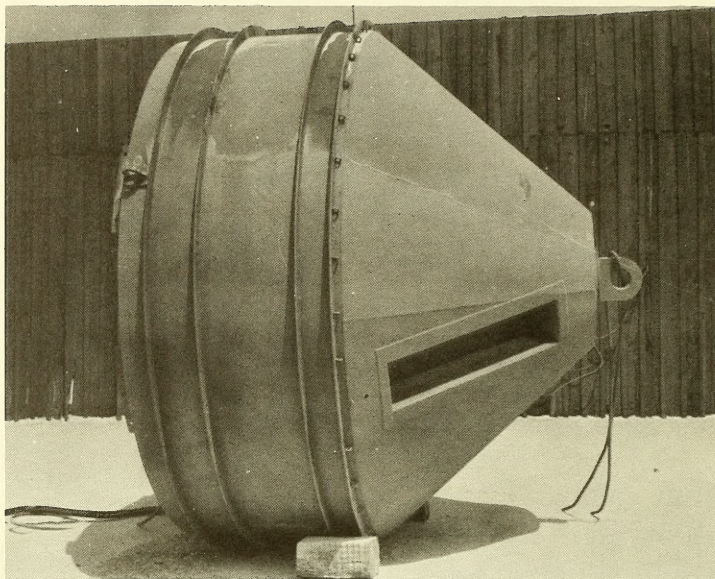
Figure 2. Test mooring buoy during sandblasting.

Two sea chests were built into opposite sides of the buoy cone, each to house a cathodic protection unit. The modified buoy was sandblasted to white metal (Figure 2) and coated with the phenolic mastic coating system described in Reference 3. The automatic control heads were bolted to threaded studs located inside the sea chests, and 80-pound magnesium anodes were secured between them and the lower mounting brackets (Figure 3). Nylon spacers were used to isolate the anodes electrically from the buoy; thus, current from the anodes had to pass through the control heads and the connected ground cables before reaching the buoy. Each of the two ground cables was threaded through a series of chain links that were welded to the bottom flange and then was welded to the flange at a point opposite the sea chest from which it came (Figure 4). Immediately before placing the buoy in service, a square-foot section of coating on the underwater portion of the buoy was sandblasted to bare steel (Figure 4), giving an exposed steel specimen on which the effect of cathodic protection could be determined visually.

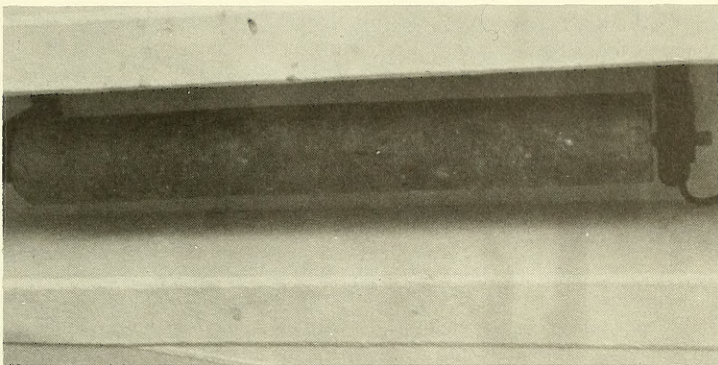
Figure 3. Cathodic protection unit in sea chest in buoy.

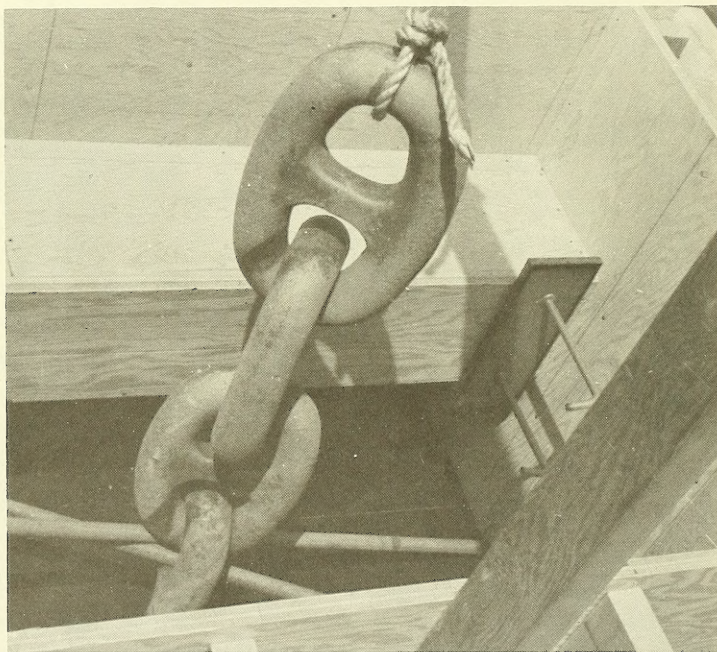
Four concrete sinker blocks were specially fabricated to hold the cathodic protection units for the ground legs. Each sinker block was prepared in a wooden form with a slot cut out to house a unit. Three and one-half 2-1/4-inch chain links were cast into the block as shown in Figure 5. Threaded J-bolts used to secure the cathodic protection equipment in place were also cast into the concrete. A cathodic protection unit similar to those on the buoy was attached to each of the sinker blocks. Each control head had two 100-foot ground cables of no. 2 neoprene-insulated, stranded copper wire attached to them.

Figure 5. Chain links in wooden form ready for casting of concrete sinker block.

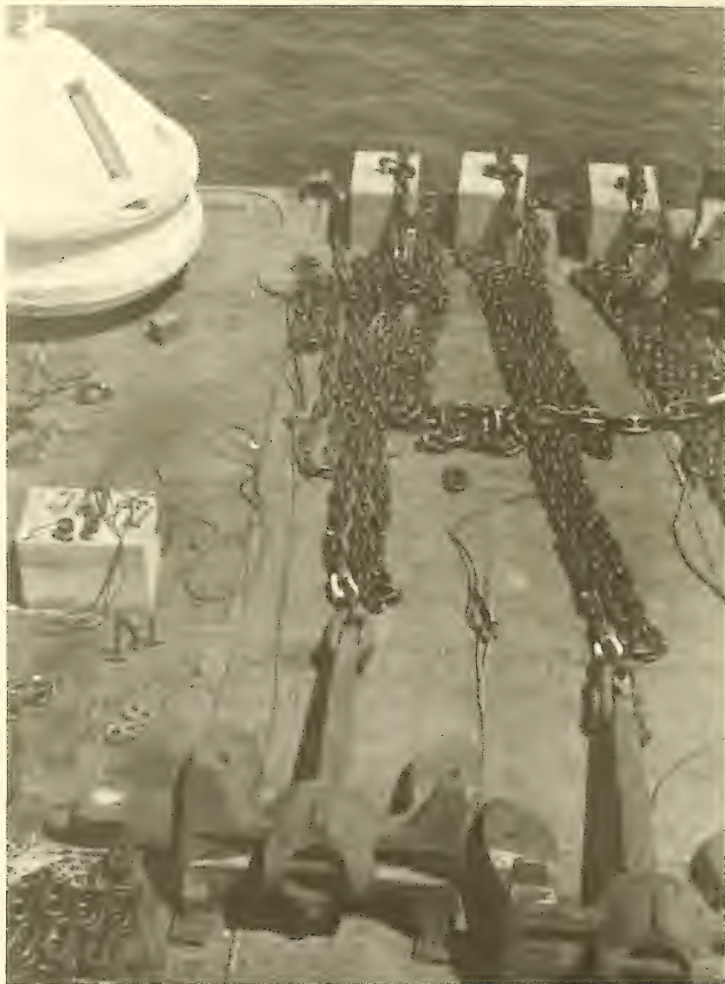
Installation. The entire mooring complex was placed on the deck of a floating crane in position for laying (Figure 6). The two ground cables connected to the control head in each sinker block were coiled and tucked inside the groove in the block (Figure 7) to protect them from damage during laying operations. A 75-foot length of similar cable was welded to the second A-link from the ground ring, and a 50-foot length of cable was welded to the second A-link from the anchor of each ground leg. These cables were also coiled tightly and tied in place prior to laying operations. A tight mooring was carefully placed in its assigned location in the San Diego Bay.

Figure 6. Initially designed system prepared for laying.

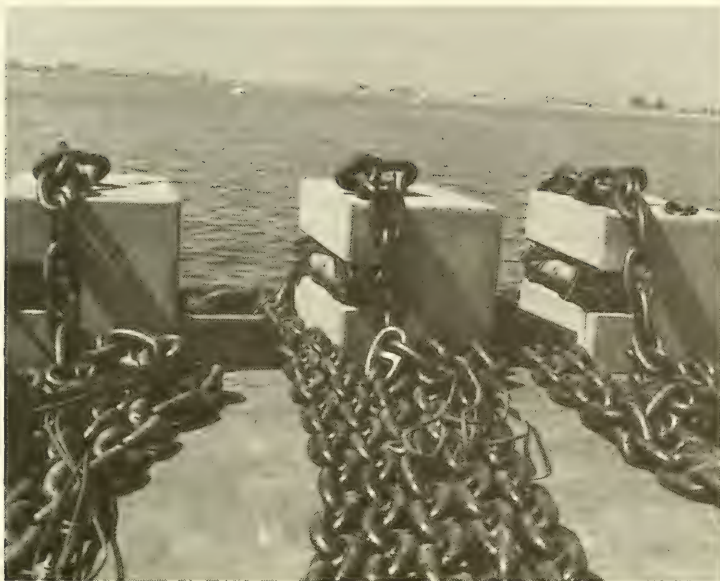
Three days after the mooring had been layed, the cathodic protection units on the ground legs were connected for service. Two of the four sinker blocks were found by divers to be lying on the side containing the unit. The blocks were righted, and the ground cables on each unit were uncoiled and connected as follows. The free end of the cable from the control head and the free end of the cable attached near the ground ring were brought to the surface. The lugs on each end were joined with a nut and bolt and were silver-soldered together to insure electrical continuity. The joined cables were then allowed to sink to the bottom of the bay. The second cable on the control head and the cable attached near the anchor were similarly joined to give the electrical circuitry shown in Figure 1. The riser-chain was then shortened to 23 feet so that the ground ring just touched bottom at mean lower low water in this 38-foot-depth location.

Figure 7. Sinker blocks housing cathodic protection units with coiled cables prior to laying of system.

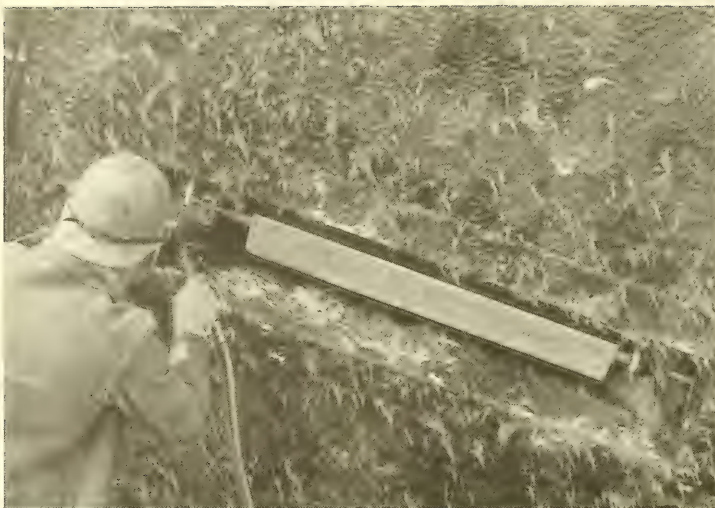
inside the steel pipe on which the zinc anode had been cast and were silver-soldered to the pipe (Figure 8). Thus, the control heads were bypassed in the circuitry and served merely as securing brackets. The connections were wrapped with electrical tape, and the buoy was returned to the water,

Figure 8. Silver soldering of ground cable to steel pipe supporting the zinc anode.

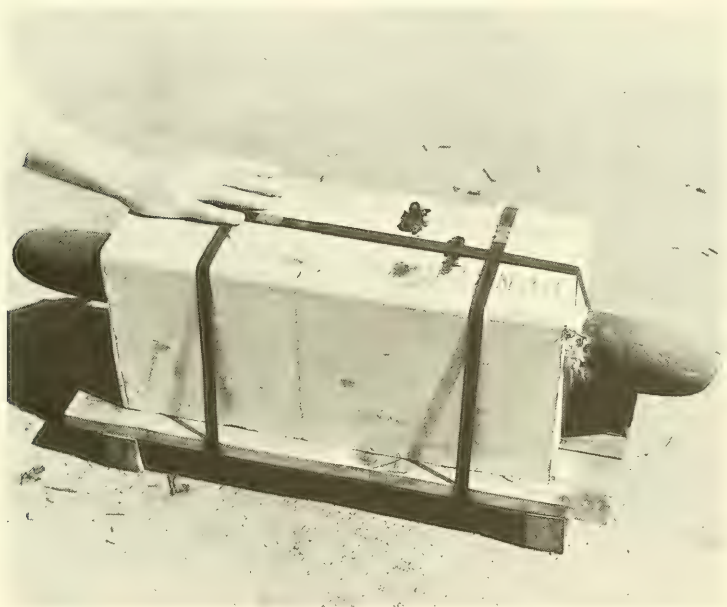
The anodes in the new cathodic protection system had to be specially manufactured. They were prepared by casting SA-3 zinc alloy on a 2-1/2-inch-thick, 35-inch-long steel link. The zinc casting was 1.8 feet long, was approximately 6.6 ft² in total surface area, and had a trapezoidal cross section. The entire anode weighed approximately 485 pounds (Figure 9).

Figure 9. Specially cast zinc anode on chain link.

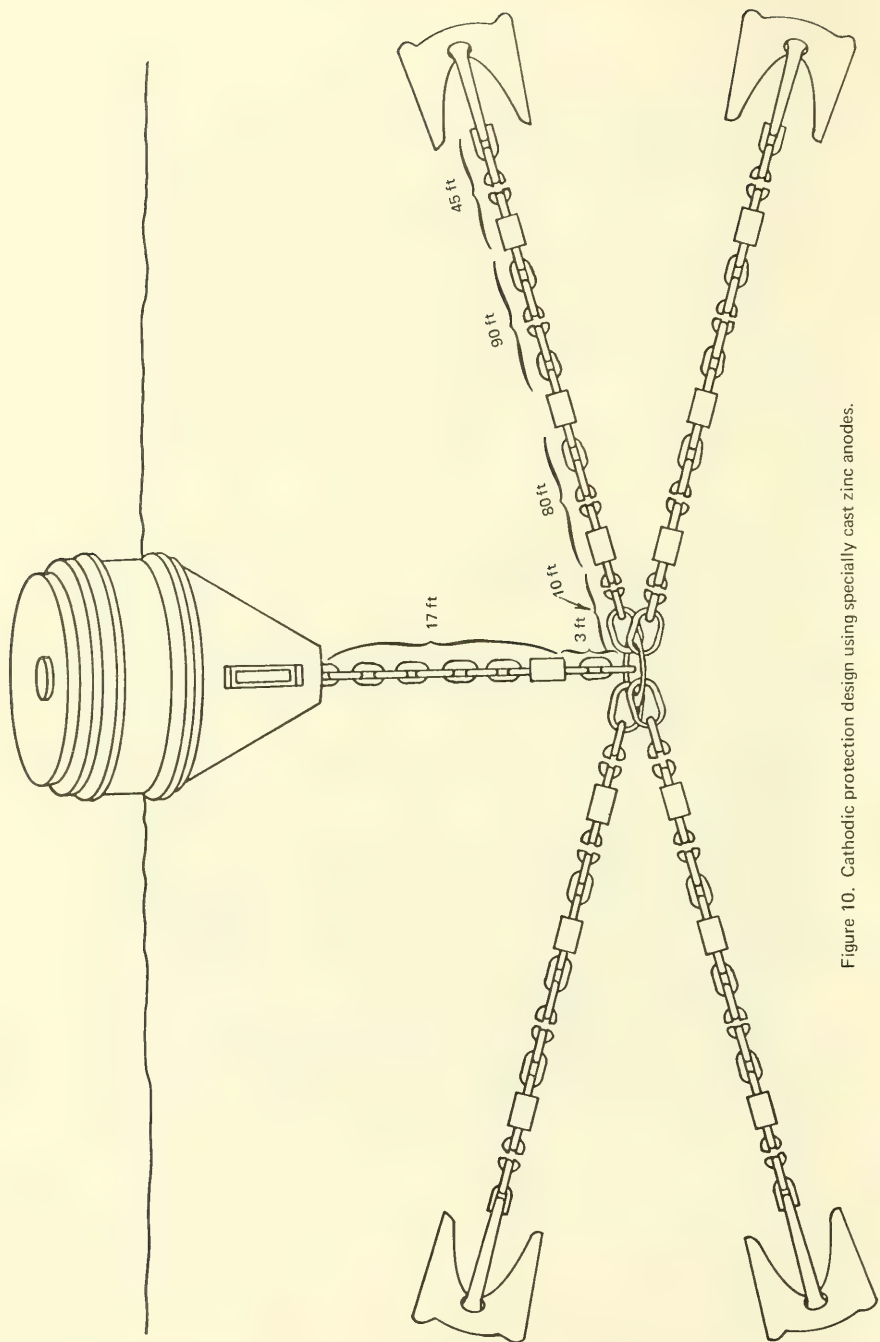
The design of the cathodic protection system is shown in Figure 10. Two of the smaller zinc anodes (approximately 144 pounds) used in the previous study on buoys were located in the sea chests on opposite sides of the buoy cone. Three of the special anodes were inserted in each leg, and one was inserted in the riser-chain approximately 3 feet above the ground ring. The anodes were secured into the recoated ground tackle using standard detachable links. With this method no place on the chain was farther than 45 feet from an anode.

Figure 10. Cathodic protection design using specially cast zinc anodes.

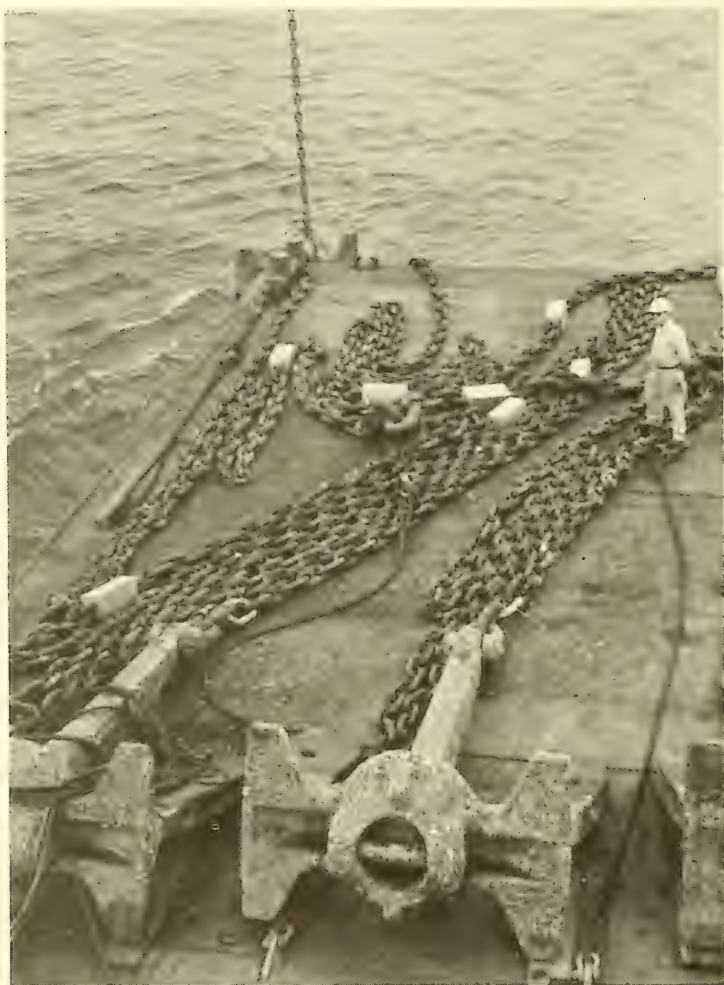
The entire mooring complex was layed out on the deck of a floating crane (Figure 11) and later carefully lowered into service to avoid abrasion or impact damage to the anodes.

Figure 11. Ground tackle with specially cast anodes on deck of floating crane rigged for laying.

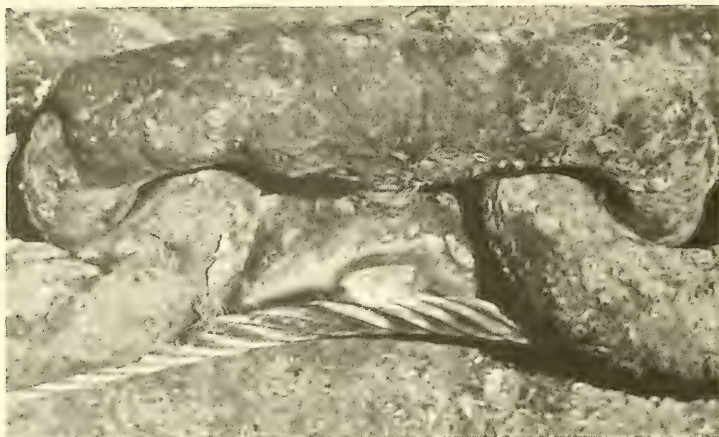
Figure 12. Cable silver-soldered to chain link.

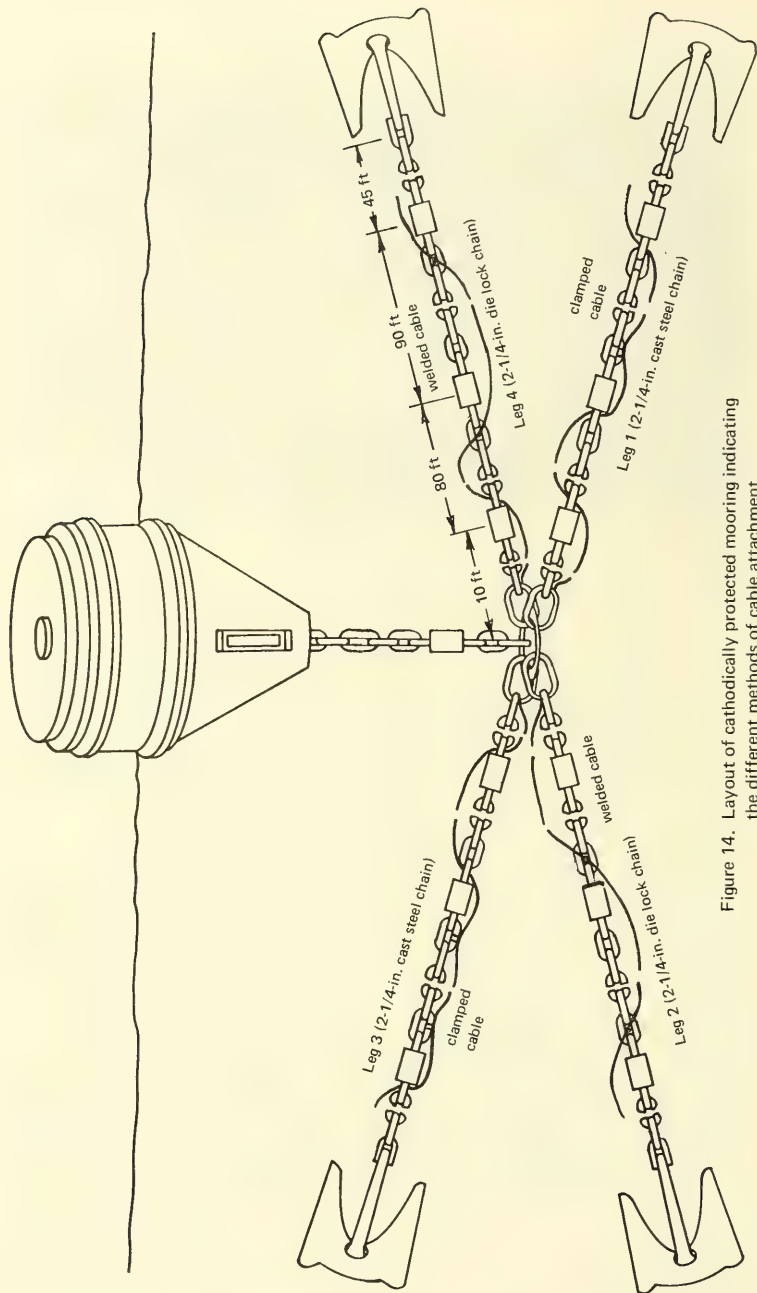
The modified cathodic protection design is shown in Figure 14. A single length of galvanized steel cable was loosely woven back and forth through every sixth link of each leg and was joined to the chain approximately every 5 feet. On two of the legs the joints were accomplished by silver soldering, and on the other they were accomplished with pipe clamps (Figure 15). The advantages of joining with pipe clamps were (1) it was faster, (2) it did not require the services of a welder, and (3) it did not require heating which might slightly decrease the strength of the heated link. The clamps were snapped into position and were then further tightened with a screwdriver. One pipe clamp was installed by a diver at the time of a later inspection to demonstrate that securing the cable underwater presented no real difficulty.

As shown in Figure 14, Legs 1 and 3 were of 2-1/4-inch cast steel chain with 3/4-inch galvanized steel cables clamped to them; Legs 2 and 4 were of 2-1/4-inch die lock chain with 3/4-inch galvanized steel cables welded to them. The cable on each leg was terminated approximately six links from the jew's harp of the anchor, rather than at the A-link nearest the anchor as in the previous test, to minimize current loss to the anchor. Thus, full protection of the chain was desired rather than partial or complete protection of the anchor.

Figure 14. Layout of cathodically protected mooring indicating the different methods of cable attachment.

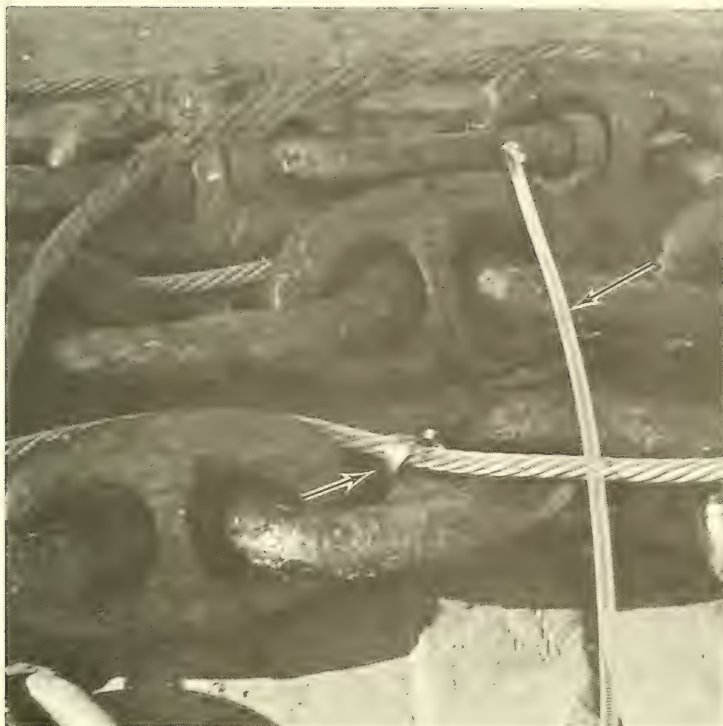
Figure 15. Cable clamped to chain link and a clamp shown prior to use.
